DEPARTMENT OF NATURAL RESOURCES  
DIVISION OF OIL, GAS AND MINING

RE: Site Inspection, Holiday Construction, Lime Ridge Mine, M/037/081, San Juan County, Utah

Date of Inspection: December 12, 2001  
Time of Inspection: 7:45 - 9:00 a.m.  
Conditions: Cloudy, intermittent light snow, less than an inch of snow on the ground  
Participants: Paul Baker, DOGM; Jason Holliday came by as I was finishing the inspection

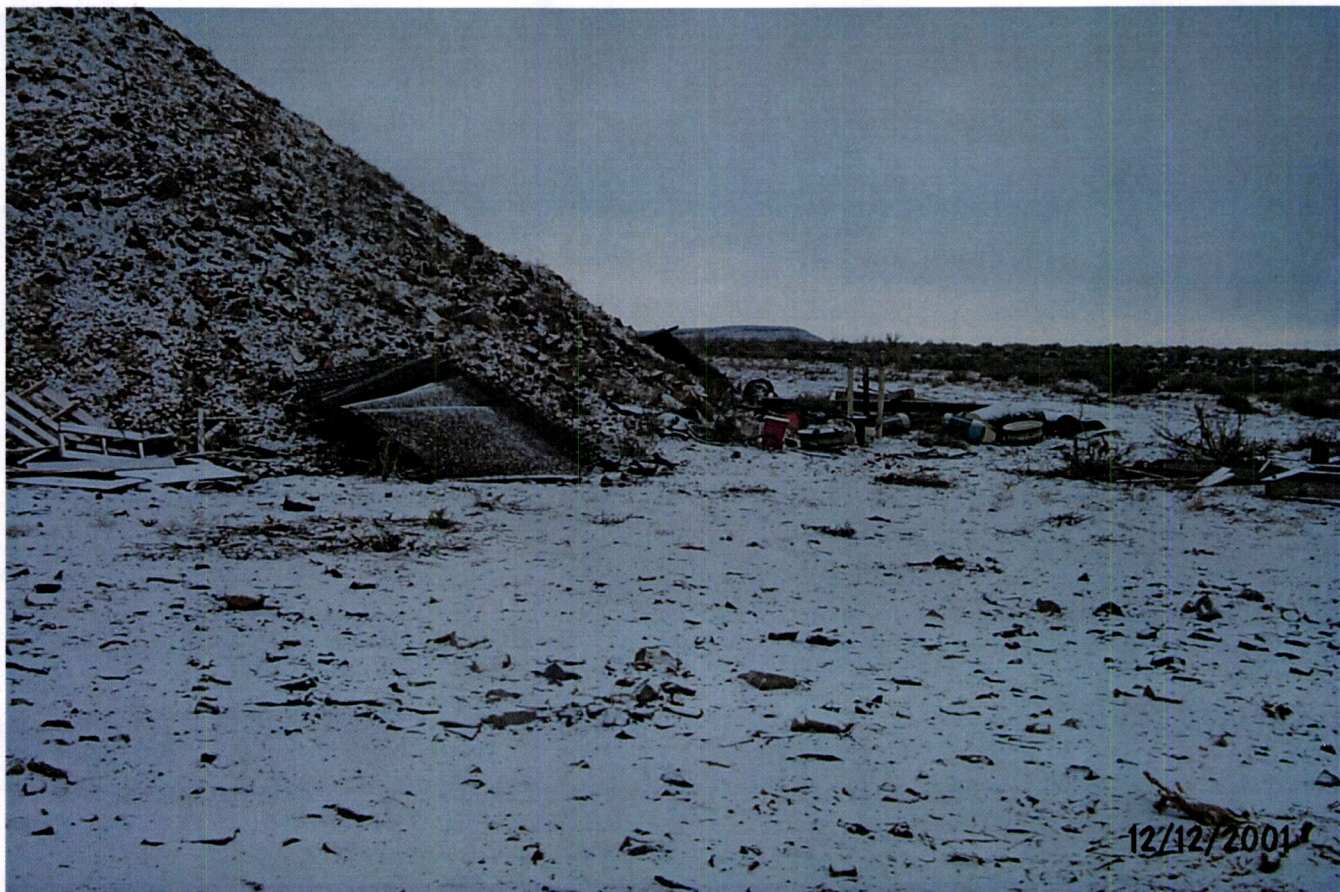
Photo 1

There is a lot of trash next to and on the easternmost topsoil pile (see photo 1). The trash includes old pallets and hydraulic oil buckets. Some of these buckets were empty, but some had oil.

The trash needs to be cleaned up. The plan indicates it is hauled out every night.

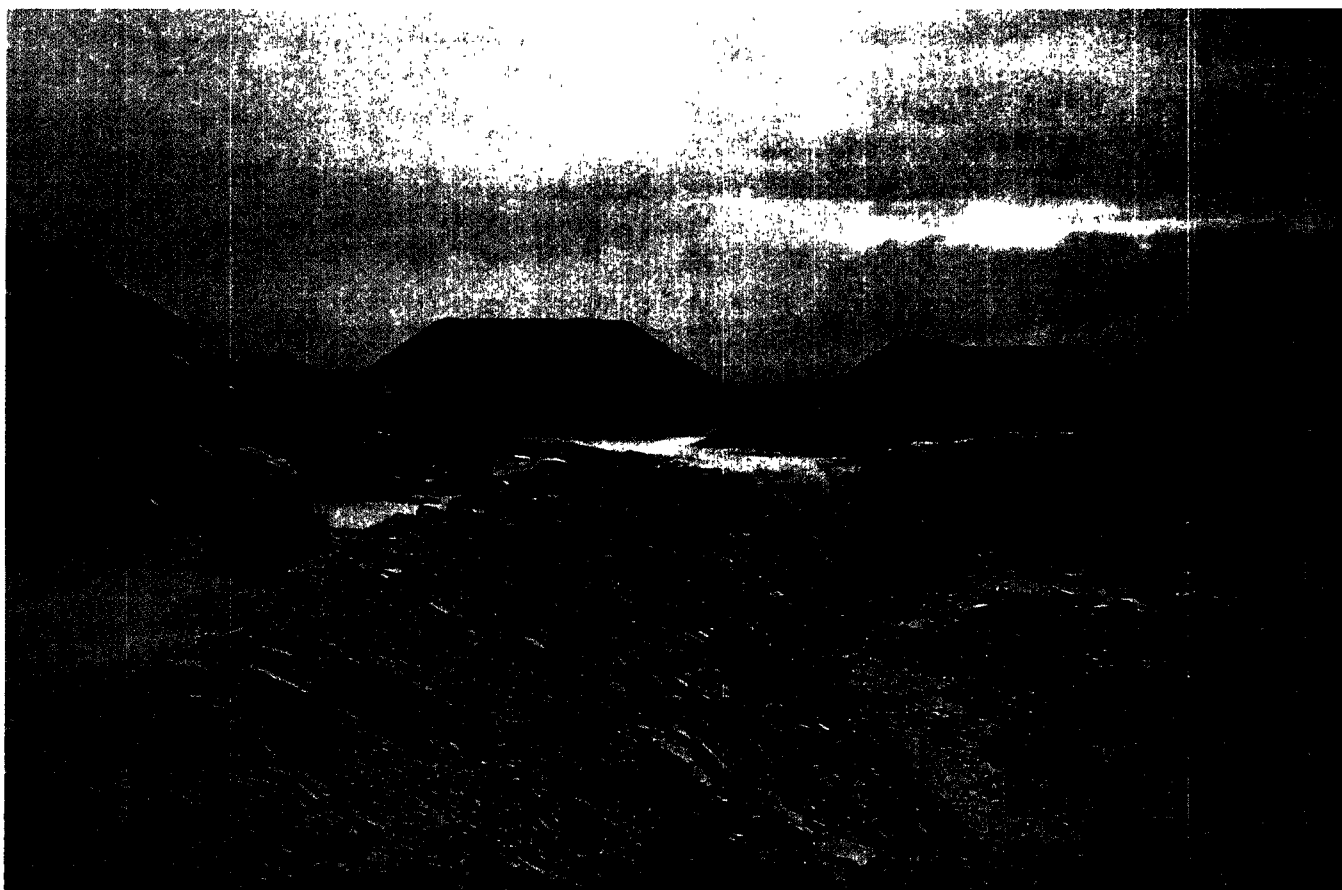
Photo 4

There is no consolidated plan, but I found commitments in responses to the five reviews of the notice of intention. One of the requirements is that there would be a four-foot berm along the edge

of the county road near the pit, and there should also be signs indicating the hazard. I found neither a four-foot berm nor signs (photo 4, road is on the left).

A sign needs to be placed on the topsoil pile(s) on the west side of the site, and the operator needs to install a berm and a warning sign where the county road is next to the pit. The topsoil piles should be reseeded unless they are going to be used soon.

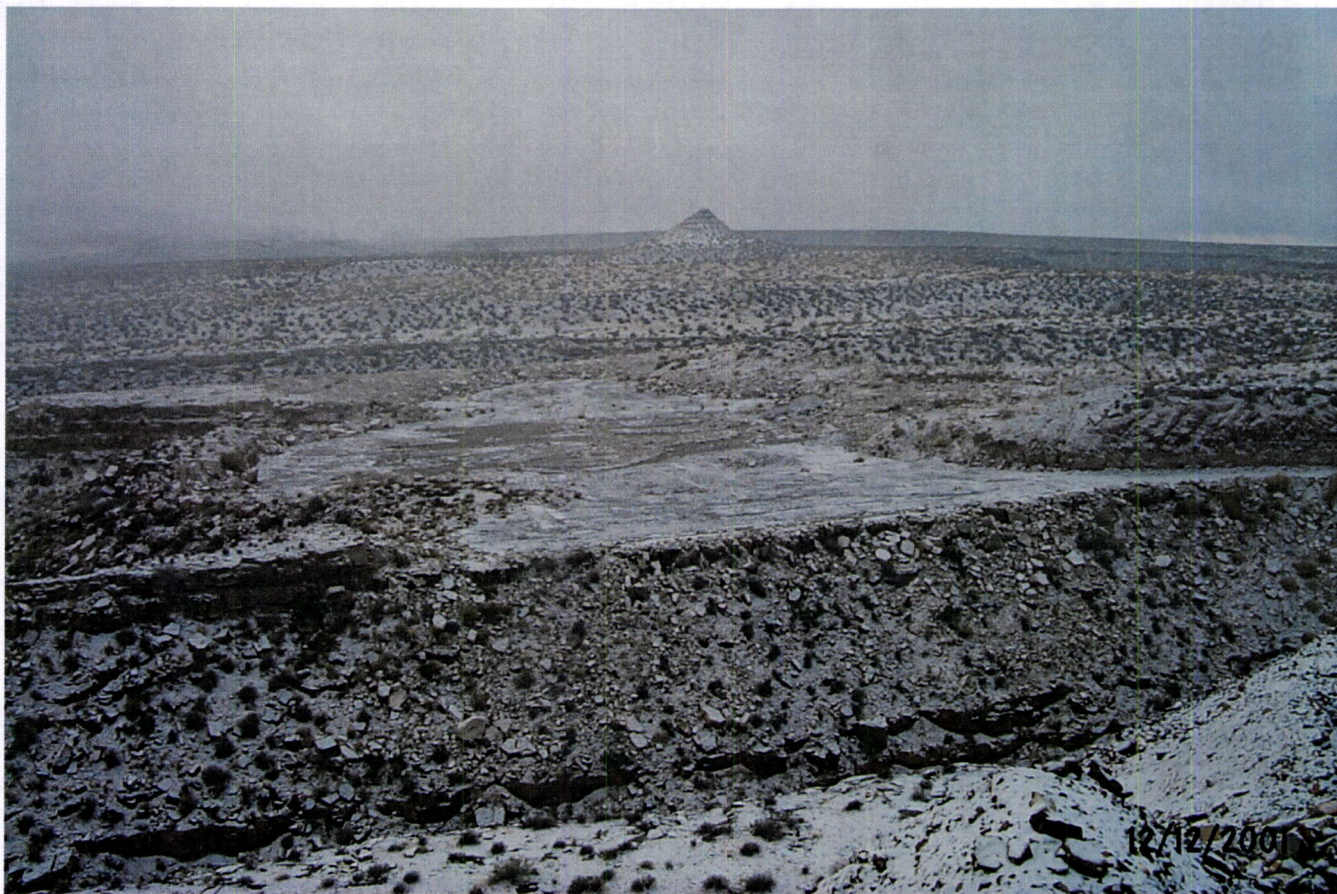
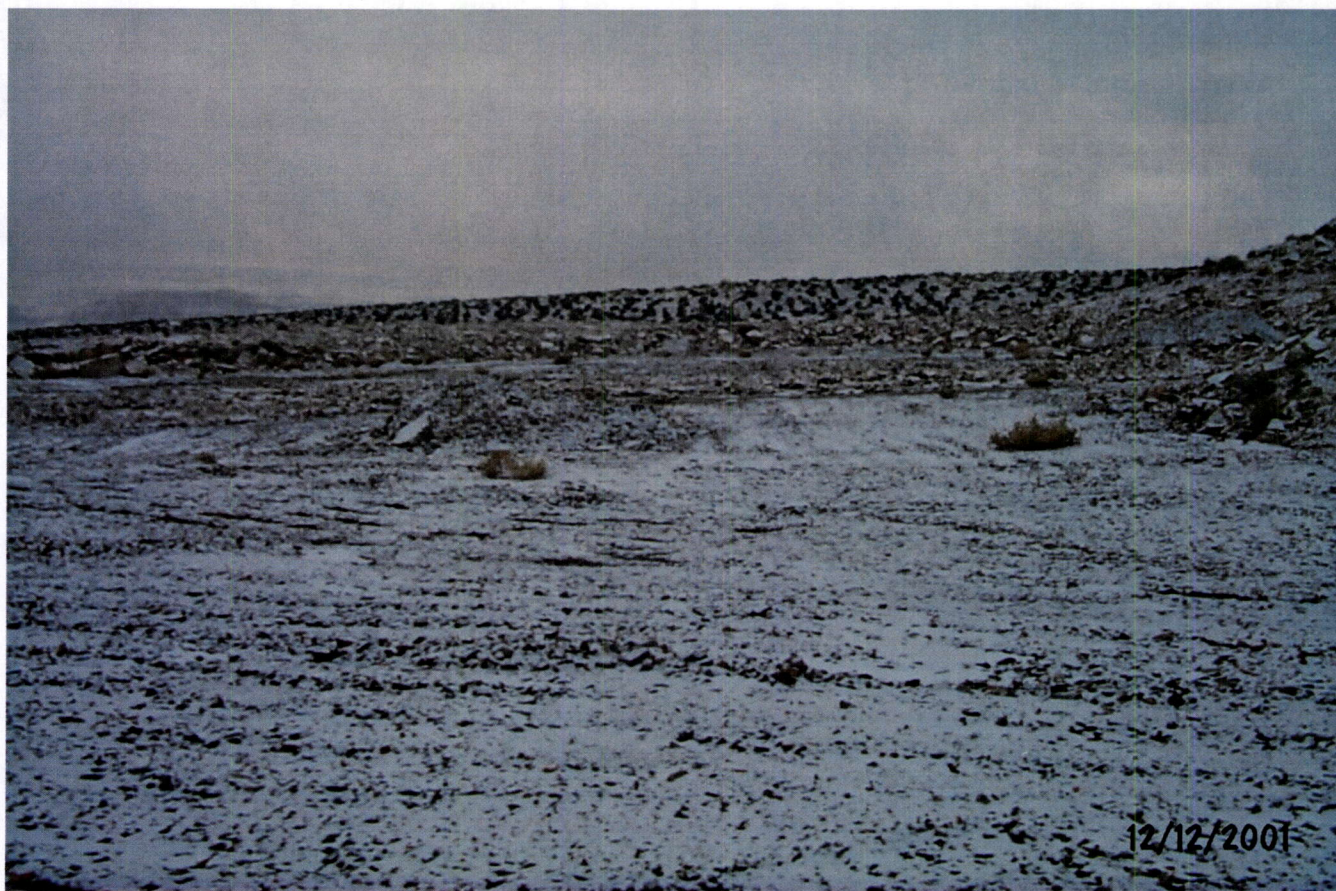
Photo 5

To the south of the main operations area is an area labeled on Figure 1 as Mining Area (Old) Site C (see photos 5 and 6). Mr. Holliday indicated there is a chance this area could still be mined, but it would not be difficult to reclaim. There is minimal waste material, and the area is fairly flat.

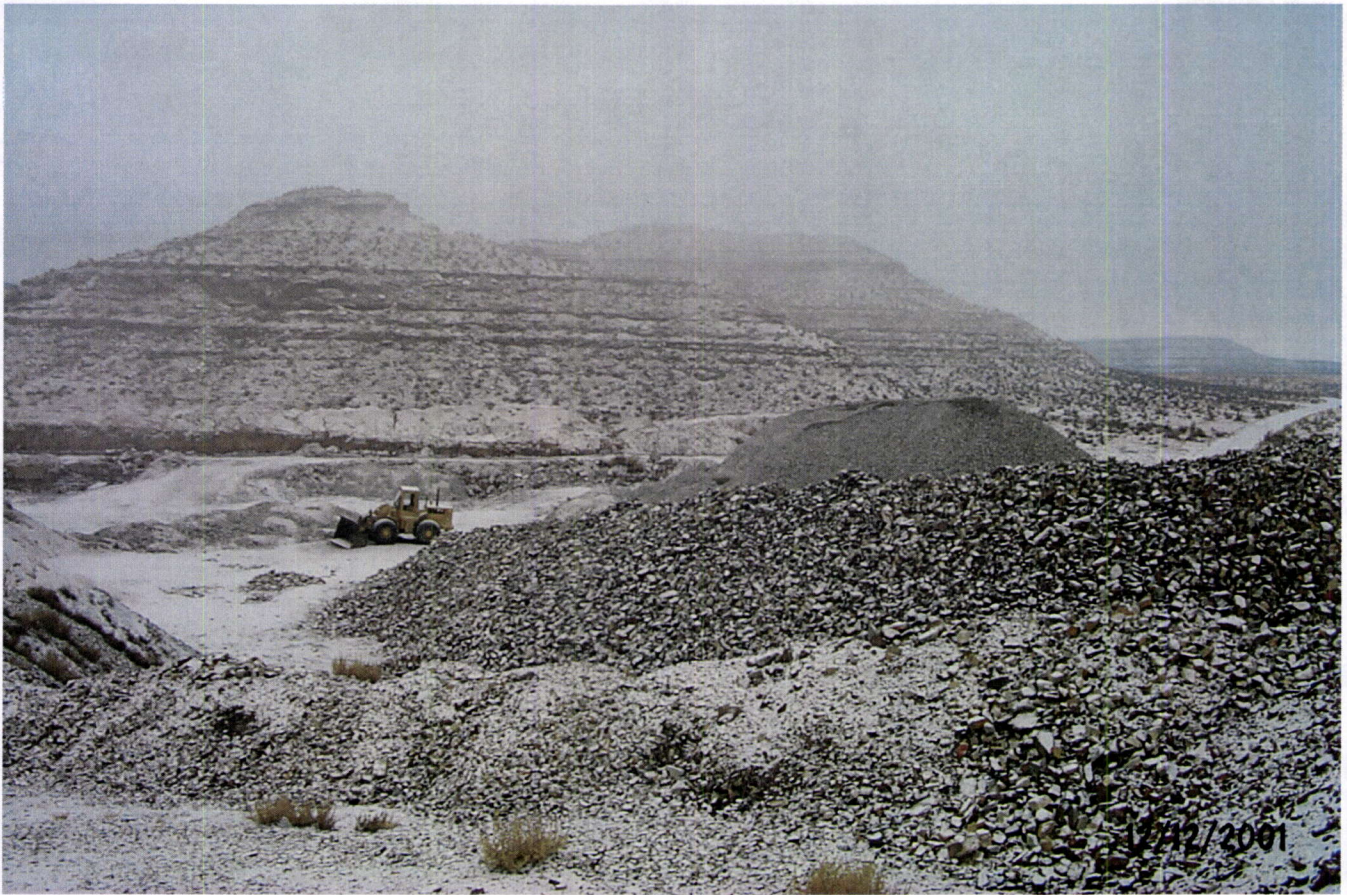
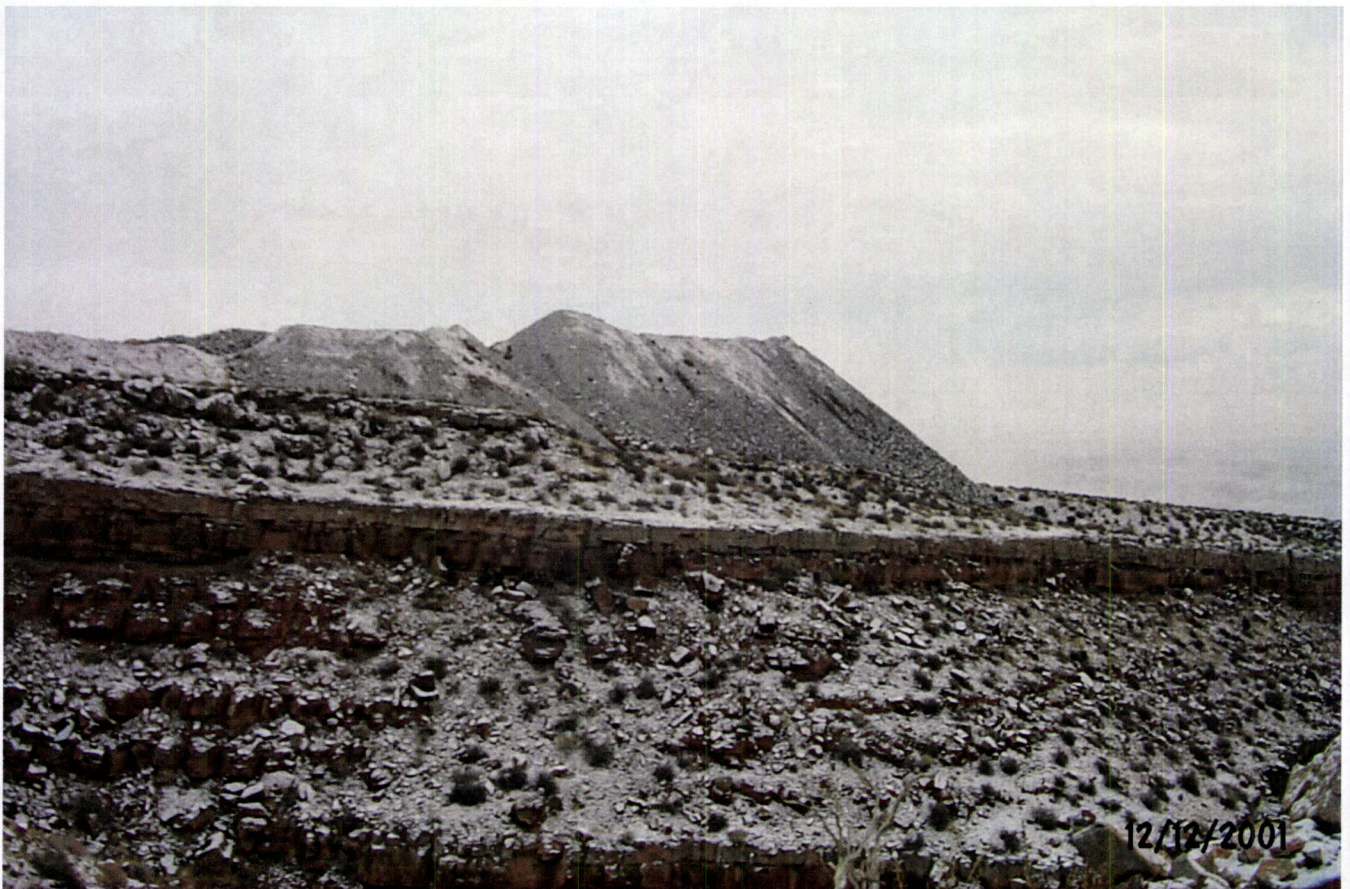
Photo 7

The plan says there would be 2000 tons of overburden and 25,000 tons of stockpiled materials that would need to be regraded. I made a rough estimate of the volume and tonnage in one of the reject piles. Based on this estimate, I believe the tonnages in the plan are approximately correct (see photos 7 and 8).

When the site is next inspected, the inspector should make better estimates of volumes of reject materials and estimate again whether the figures in the plan are accurate. The inspector should also check for any offsite damage from sediment and see whether there is an entrance sign.
